Analysis of the Impact of Soil on Gully Erosion in Tumfure, Gombe Urban, Gombe State, Nigeria

Abstract

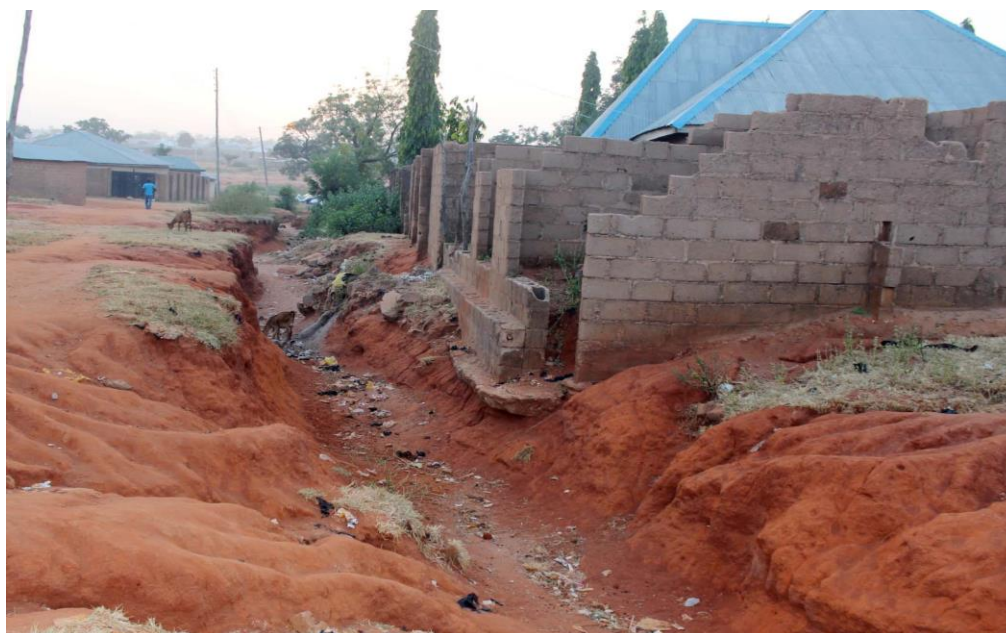
Plate 1: Exposed foundation of a house at the verge of collapsing due to gully activities

Field observations revealed cracked houses and falling of buildings into gullies are common features in the gully prone areas, while several others are at the risk of losing their houses and livelihood to gully erosion (Plate 1 and 2) if no holistic control measures are taken. As similar work by Ofomata (2007) reported that over 100 houses each year were destroyed by gully erosion in Auchi and AguluNanka communities in Nigeria.

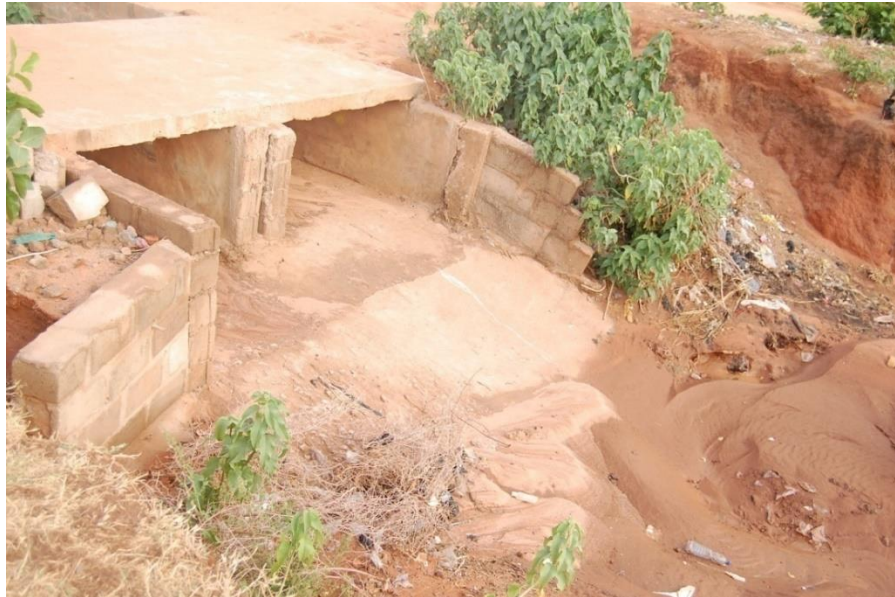
Plate 2: Collapsed Culvert along the gully site

Gully erosion in the study area has also destroyed many roads and culverts/ bridges in the study area (plates 2 and 3). Different streets/roads especially untarred culverts/ bridges and foot paths were destroyed thereby increasing the cost of intra city transport in the study area. Also, several other undeveloped plots of land were destroyed and others at the verge of destruction due to lack of proper drainage channel in the area.

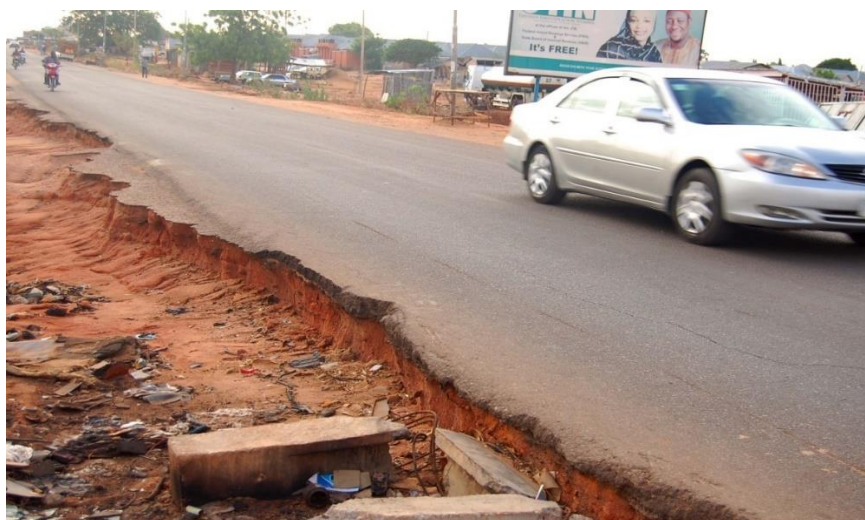
Plate 3: Cutting down of Bauchi-Gombe road by gully erosion
