SPATIOTEMPORAL CHANGES IN THE CHANNEL HYDROMORPHOLOGY OF RIVER YEDZERAM SECTION AND ITS IMPACTS IN SURROUNDINGS, NORTH EAST NIGERIA

The complex structure of rivers and increasing interest in quantitatively representing this complex structure has motivated the study of river dynamics, which has become an important subject in river science. This study analyzed spatiotemporal changes in the channel morphology of River Yedzeram section and its impacts in surroundings, North East Nigeria, Recent changes in the channel morphology of River Yedzeram segment from Wuro-Harde to Tappare Babeti Mubi North; Adamawa State of Nigeria was evaluated using thorough fieldwork and Geographical Information System (GIS) Analysis. Modifications such as channel width, channel depth, channel sinuosity and lateral channel movement processes in the channel segment were examined over the period of 13 years (2006 to 2019). The Results depicted that from 2006 to 2011 the average migration magnitude was 20.51m while the average migration rate was 3.96m/year). From 2011 to 2015 the average migration magnitude was 20.34m while the rate of migration was 4.39m/year. From 2015 to 2019 the average migration magnitude

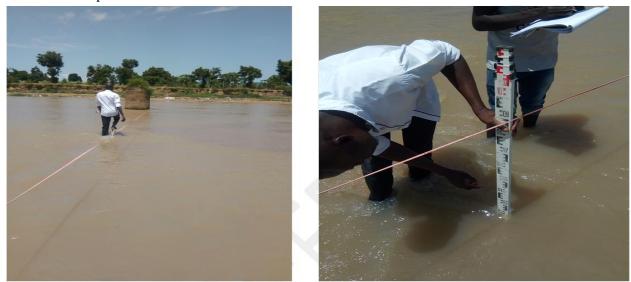
Plate 1: Methods of determining the width and depth of channel Source: Fieldwork 2019

Short term channel deepening assessment was conducted mainly by field measurement procedures. In 2018 and 2019, the bed level of the studied river channel section was measured with survey procedure involving the use of leveling staff. The exercise was conducted as an initial routine for

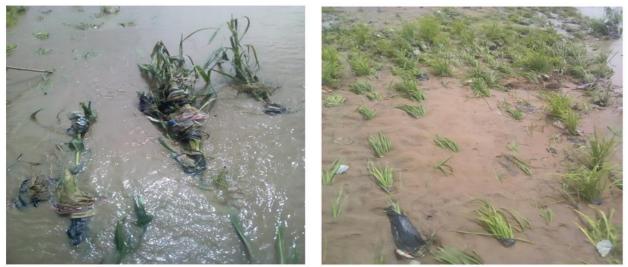
Plate 2 and 3: Effects of channel width changes on rice farm Source: Fieldwork 2019.

Careful observation revealed that channel width changes have played vital roles in the production and contribution in the aggradation and degradation of soil in the river channel which affected various land uses (agriculture, transportation and construction of hydraulic structures). A close study of the irrigation agricultural land use zone around the river channel confirmed that the denuded areas of the zone resulted from intense annual volume of water which resulted to crop destruction with little or no soil conservation measures, (plate 2 and 3).
